# **INDOOR AIR QUALITY ASSESSMENT**

**Quarry Hill Community School  
43 Margaret Street  
Monson, Massachusetts**

Prepared by:  
Massachusetts Department of Public Health  
Bureau of Environmental Health  
Indoor Air Quality Program  
November 2017

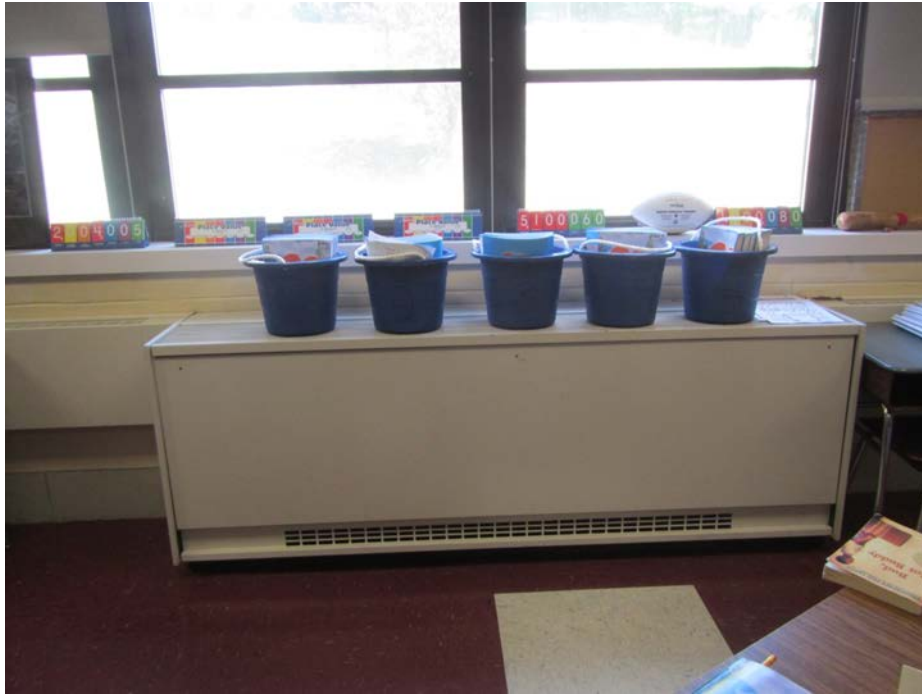
**Picture 1**

Fresh air in classrooms is supplied by unit ventilator (univent) systems (Picture 1). A univent draws air from outdoors through a fresh air intake located on the exterior wall of the building (Picture 2) and returns air through an air intake located at the base of the unit (Figure 1). Fresh and return air are mixed, filtered, heated, and provided to classrooms through a fresh air diffuser located in the top of the unit. BEH/IAQ staff spot checked univent cabinets in a few areas. Each univent has a pleated filter. Spaces were observed between the univent cabinet and the post filtration component of the univent, which results in the distribution of unfiltered/unconditioned air into the classroom (Picture 3). Additionally, dust and debris were noted within the univent air chambers, and filter changes did not appear recent (Picture 4).

Univents were found deactivated in classrooms throughout the school. Obstructions to airflow, such as papers and books stored on univents and bookcases and/or carts and desks located in front of univent returns, were also observed in a few classrooms (Picture 1). In order for univents to provide fresh air as designed, intakes must remain free of obstructions; importantly these units must remain “on” and allowed to operate while rooms are occupied. Some items on top of or near the univent (e.g., plastic, crayons) can become sources of odor when heated.

**Classroom univent, note plastic buckets placed on top of unit**

5. Remove any blockages to univents, including items placed on top of the units. Plastic and wax-based materials should not be placed on these units, since heating these items can create odors.

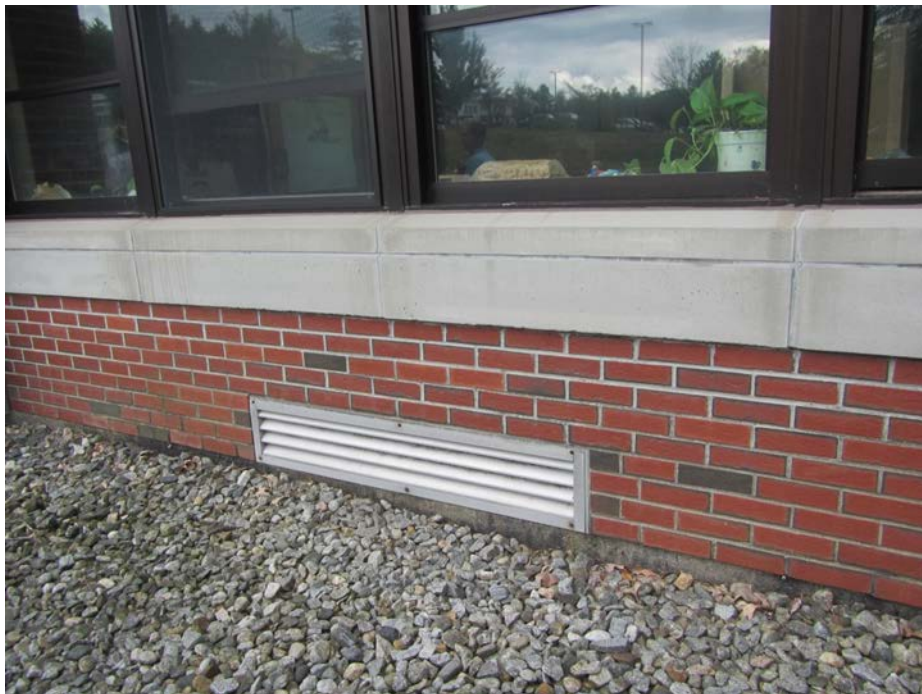
**Picture 2**

**Univent fresh air intake**

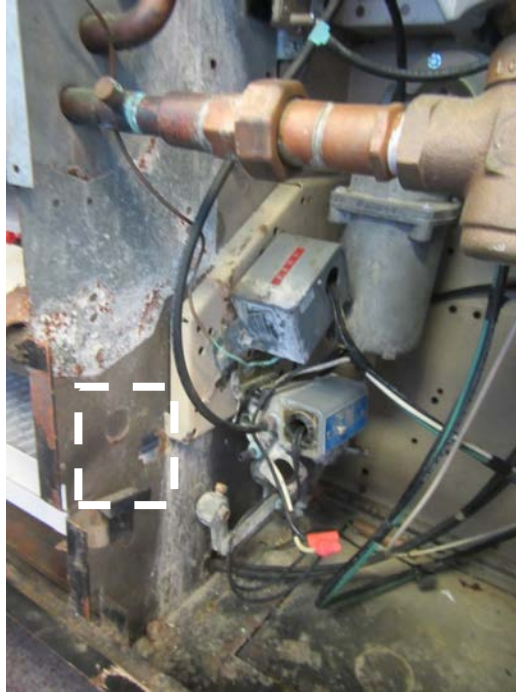
**Picture 3**

**Breaches in univent cabinet; air drawn into unit can by-pass filtration**

1. Continue with recommendations made in the August 2017 Pool report (MDPH, 2017).
2. Operate all supply and exhaust ventilation equipment continuously during occupied periods.
3. Seal breaches in the univent cabinets to prevent unfiltered air from being distributed by the units.
4. Change univent/HVAC filters regularly.

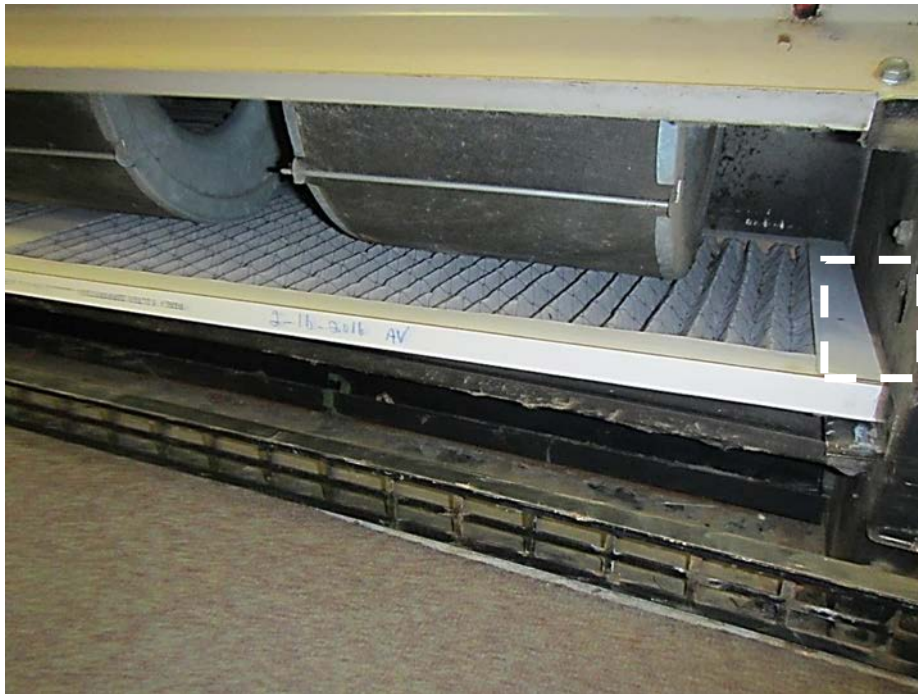
**Picture 4**

**Pleated univent filter with last change date is February 2016; note air by-pass**

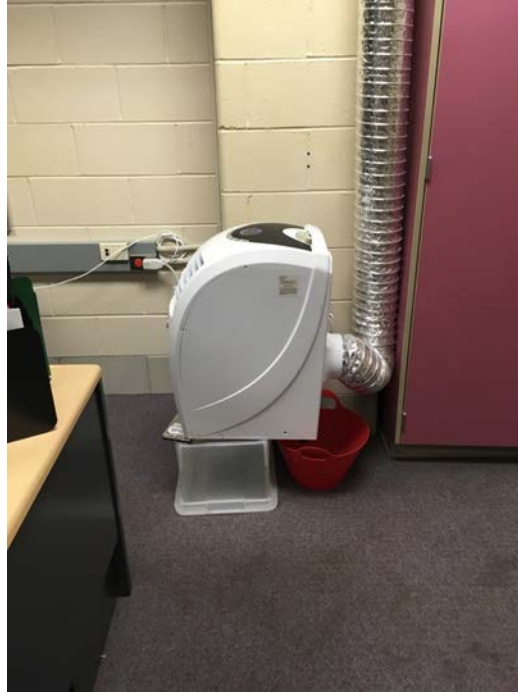
**Picture 5**

Window-mounted and portable air-conditioning (AC) units were observed in a number of areas (Picture 5). These units can provide fresh, filtered air when used in the fan mode. Filters should be cleaned per manufacturer's recommendations or more routinely if used on a regular basis. In some instances, receptacles were placed under these units to collect condensate; however, debris was observed in these buckets (Picture 6). Such material can be a source mold growth and odors.

**Portable classroom AC unit**

7. Ensure filters to window-mounted and portable air-conditioning units are cleaned regularly.
8. Use openable windows and/or the fan mode of window-mounted air-conditioning units to supplement fresh air during temperate weather. Ensure all windows are tightly closed at the end of the day.

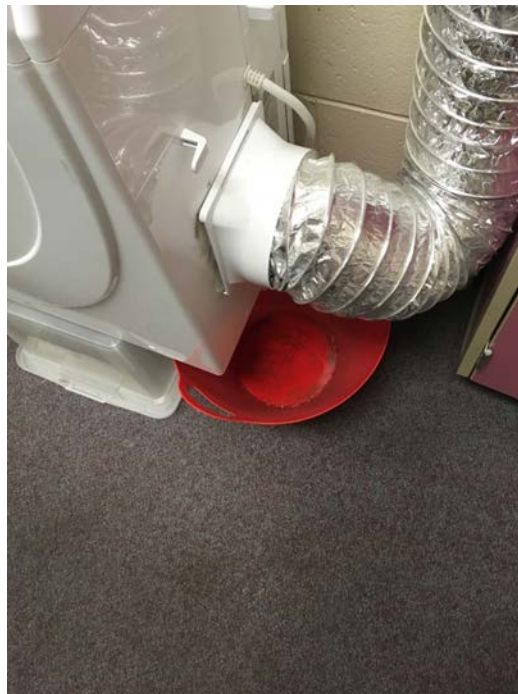
**Picture 6**

**Note debris in water receptacle located below portable AC**

14. Empty and clean the dehumidifier regularly to prevent odors and growth of bacteria in condensate receptacle. Similarly, empty and clean receptacles used for collecting condensate from portable ACs.

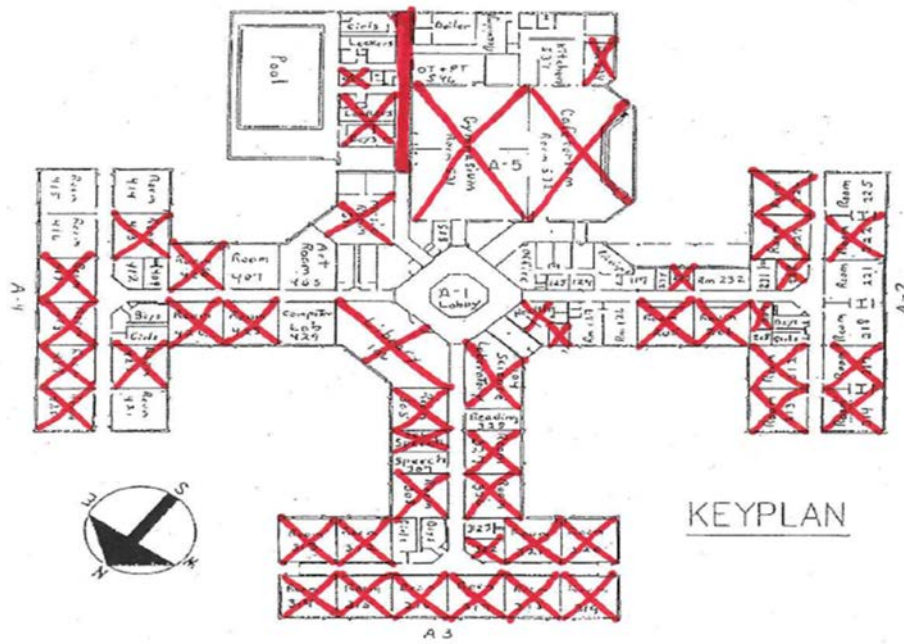
Picture 7

As part of an IAQ investigation, temperature and relative humidity measurements are taken indoors in occupied rooms/areas, as well as outdoors. These measurements are also useful for identifying whether water vapor from the pool is traveling to other sections of the building. Under normal operation of the HVAC system during the non-heating season, classroom units introduce unconditioned air from outdoors as would open windows. In the experience of the BEH/IAQ Program, relative humidity indoors would be expected to be either equal to or less than background (outdoor) relative humidity measurements taken the day of assessment. During this assessment, outdoor humidity was 44 %. Over 60 locations in the QHCS had relative humidity measurements greater than the outdoor measurement, ranging from 2 to 41% (Picture 7, Table 2). When indoor temperatures are lower than the outdoor temperature, the indoor relative humidity is higher as the air volume would decrease in relation to water vapor volume. However, on the day of assessment, all temperatures measured indoors were ***higher*** than the outdoor temperature; this discounts temperature difference as a source for increased humidity.

Based on these measurements, a significant water vapor source is present within the building. The water vapor source is likely the pool and its degraded/poorly functioning HVAC equipment. Increased indoor humidity can moisten porous materials that sustain mold growth. Water vapor from pools should be vented directly outdoors to prevent movement to other indoor locations<sup>1</sup>. Water vapor with pool treatment chemicals can be irritating to the eyes, nose, and respiratory system.

Locations with relative humidity  $\geq 2\%$  over outdoor relative humidity measurements on 9/8/2017

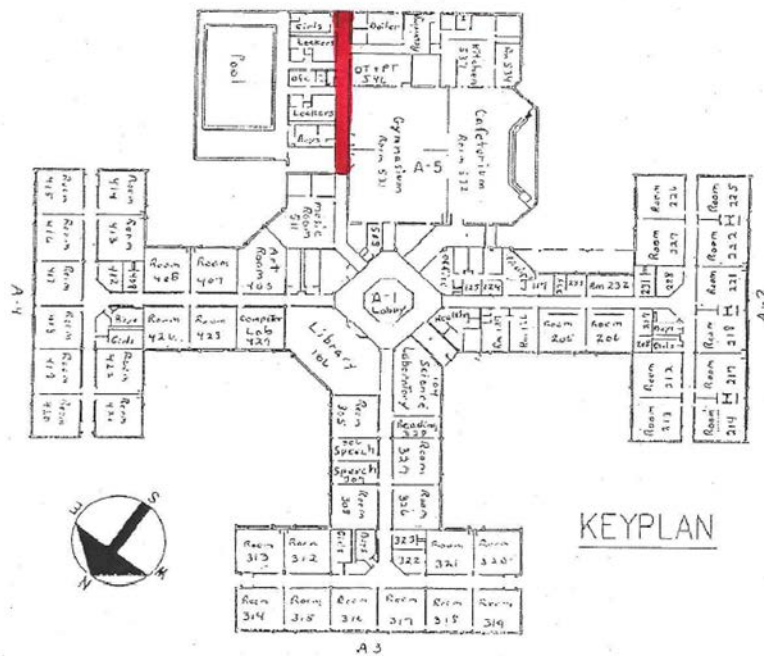
Picture 8

measured during the 2004 visit, which had only 1 area greater the +2% than outdoor background measurements (Picture 8, Table 3).

Locations with relative humidity  $> 2\%$  over outdoor relative humidity measurements on 5/28/2004

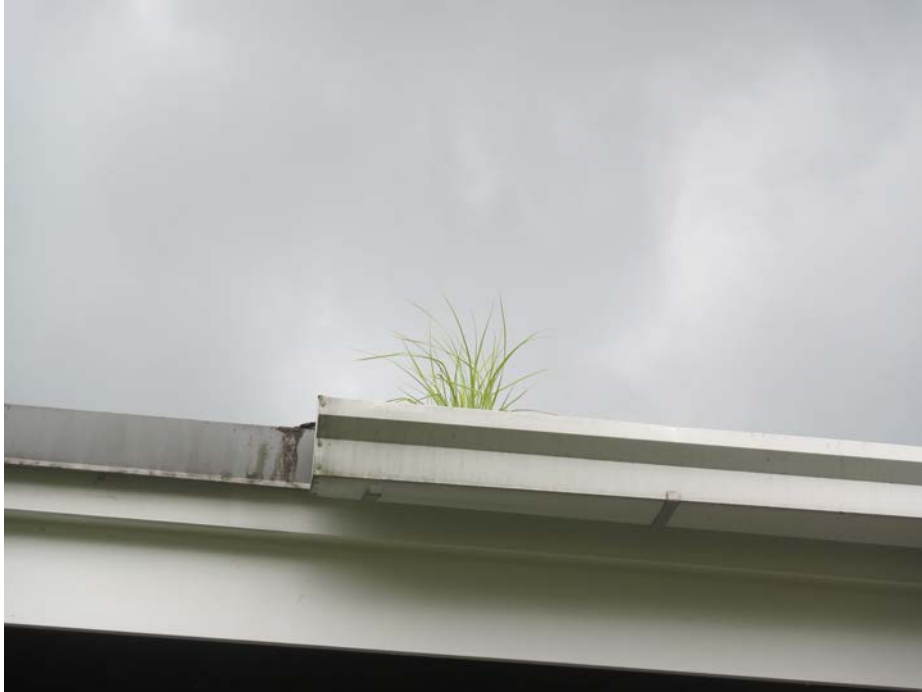
**Picture 9**

Plant growth was observed in gutters around the school (Picture 9). Such growth indicates that the gutters have not been cleared of debris in some time. Buildup of debris and growth of plants can prevent water from draining off the roof and away from the building, which can lead to water damage to the building. Gutters should be cleaned regularly to ensure proper drainage.

**Plant growth in gutter**

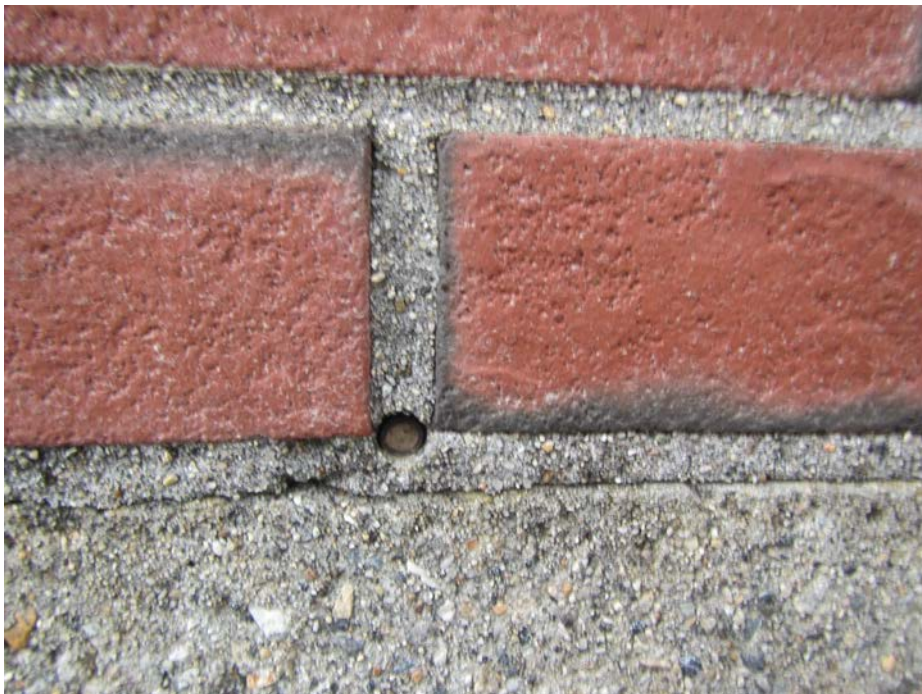
**Picture 10**

Weep holes around the building exterior appeared clogged (Picture 10). Weep holes are important in the drainage of brick buildings. Clogs can occur as a result of salt and mineral deposits carried by moisture that is draining out of the building. Weep holes should be cleared to allow for adequate drainage.

**Clogged weep hole**

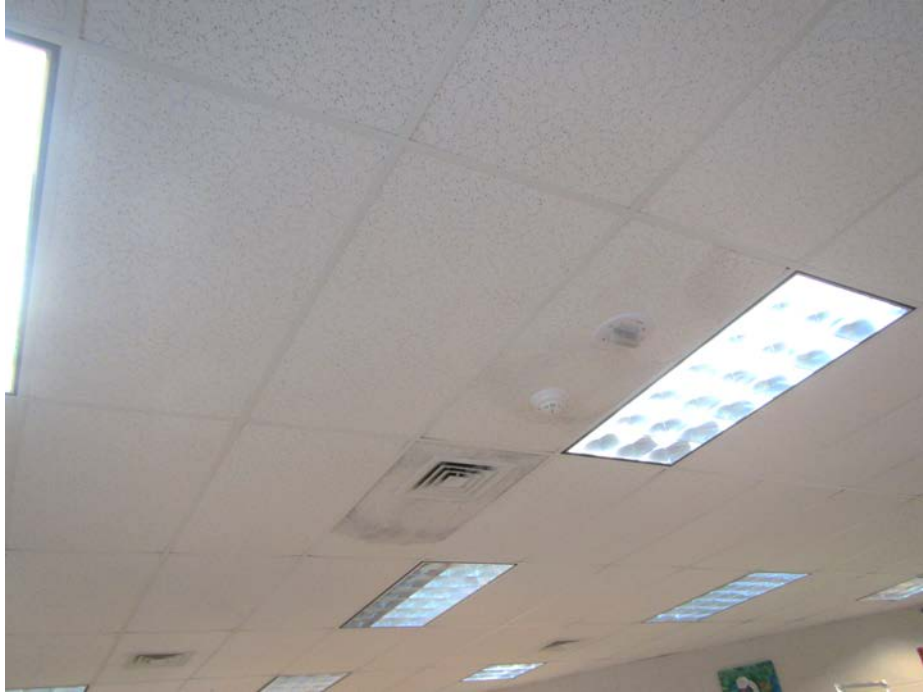
**Picture 11**

Water-damaged and missing ceiling tiles were observed in a number of areas throughout the school (Picture 11). These are indications of pipe and/or roof leaks. Measures should be taken to replace water-damaged ceiling tiles once leaks are repaired.

**Water-damaged ceiling tiles**

11. Investigate and make repairs to leaks damaging ceiling tiles. Replace water-damaged ceiling tiles.
12. Seal seams between sink countertop and backslash to prevent damage to cabinets and items stored below, as well as wall surfaces behind unit.

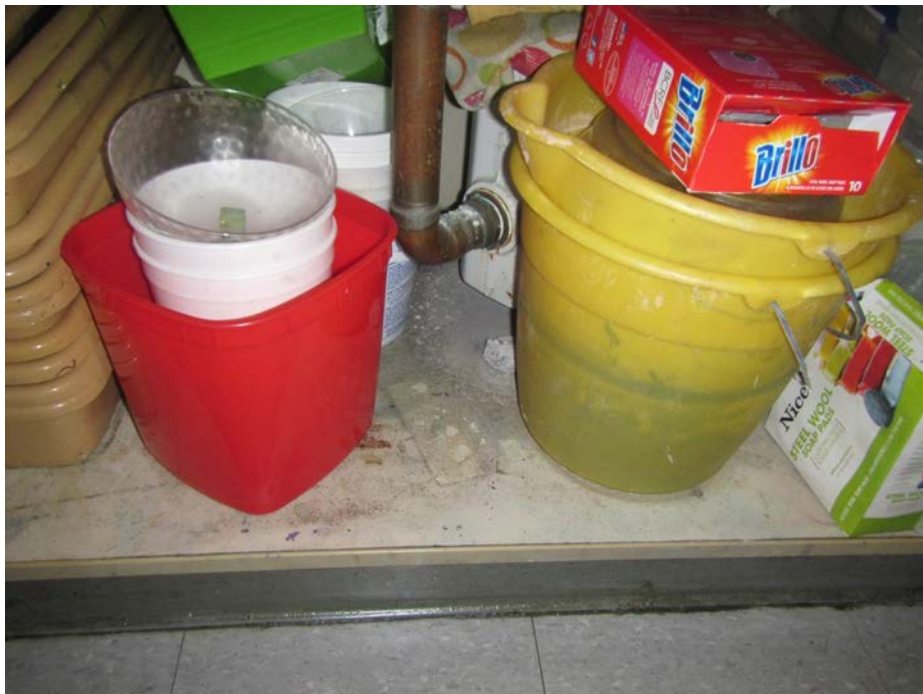
**Picture 12**

Open seams between the sink countertop and backsplash were observed in several rooms (Table 1). If seams are not watertight, water can penetrate the seam, causing water damage. Water penetration and chronic exposure of porous and wood-based materials can cause these materials to swell, show signs of water damage, and lead to potential mold growth. Damage beneath sink cabinets was observed in some areas (Picture 12). Some of the sinks had cabinets beneath them containing large amounts of items, including porous items. The area underneath sinks is a moist environment and should not be used to store items that can become colonized with mold. Large amounts of items stored under sinks can also make detecting leaks difficult.

**Water damage in sink cabinet**

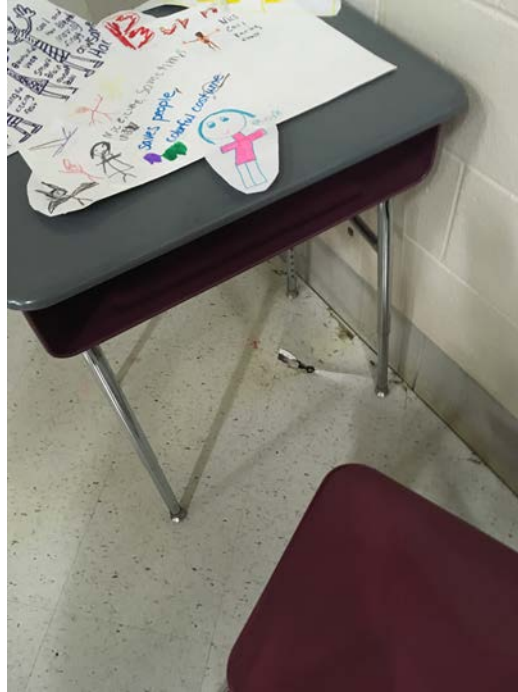
**Picture 13**

The building was constructed on slab. As confirmed by school department officials, the building slab has settled over time, and the building is shifting. The types of movement experienced by the building have resulted in cracks in floors and the foundation (Pictures 13 to 15). Shifts in the slab can also facilitate the movement of moisture from earth (beneath the slab) through cracks into classroom areas. Increases in moisture can degrade glues used to adhere carpeting; these conditions likely contribute to the rippled carpeting observed throughout the school (Picture 16). Lastly, portions of the building's exterior brick wall appeared to bow out beyond the footprint of the building's foundation. This type of lateral movement can create fissures and cracks in the brick, which can allow moisture and pests to enter the building. Over time, water trapped in brickwork can cause spalling and other damage. At the time, school department officials reported that these shifts were being monitored.

**Cracks/damage to classroom floor**

21. Cracks in floors/ripples in carpeting should be made flush (e.g., sealed, smoothed, or cut and re-glued) to prevent tripping hazards and moisture/insect penetration.

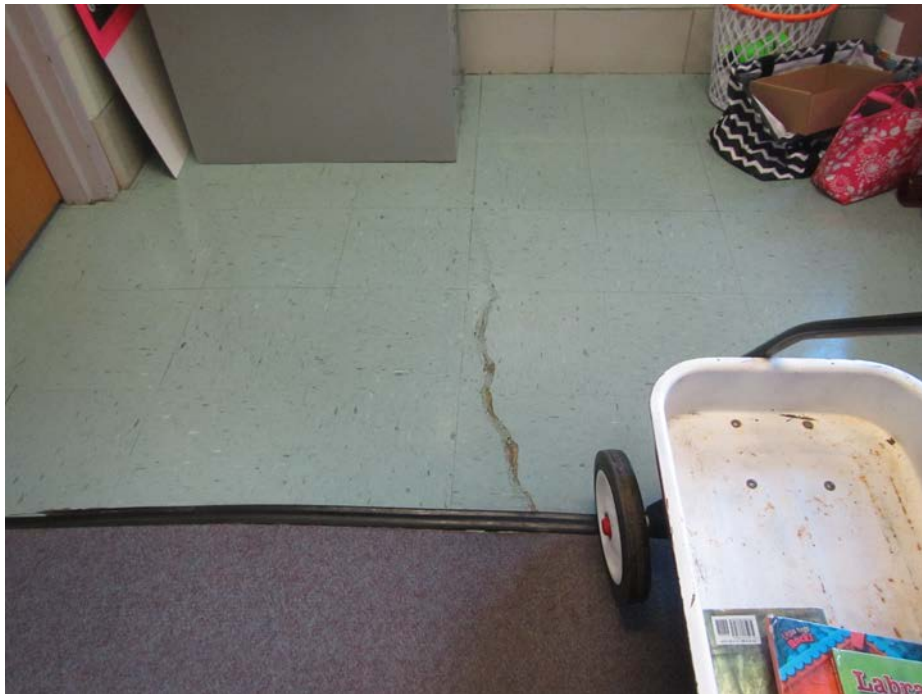
**Picture 14**

**Cracks/damage to classroom floor**

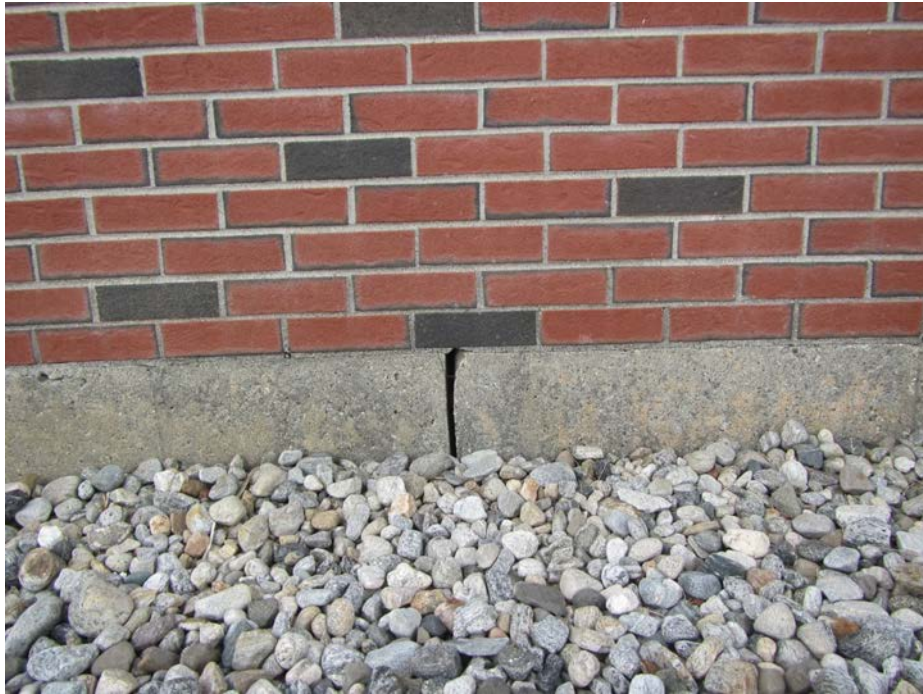
**Picture 15**

**Cracks in foundation**

20. Continue to monitor shifts and changes in the building closely as a means for identifying potential for damage that can lead to water infiltration or building material deterioration.

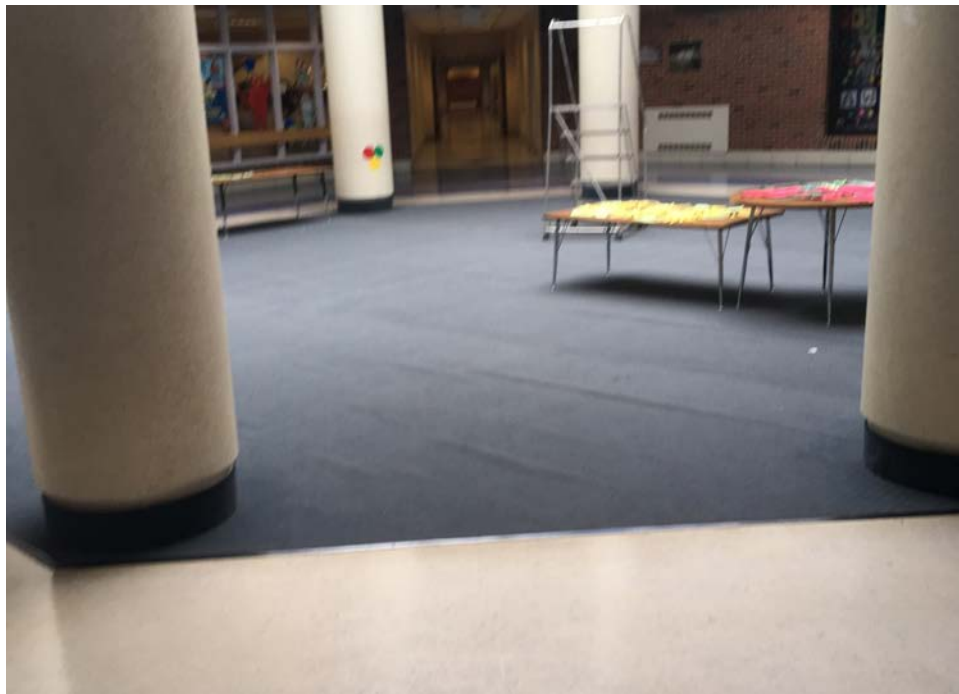
**Picture 16**

**Rippled carpet**

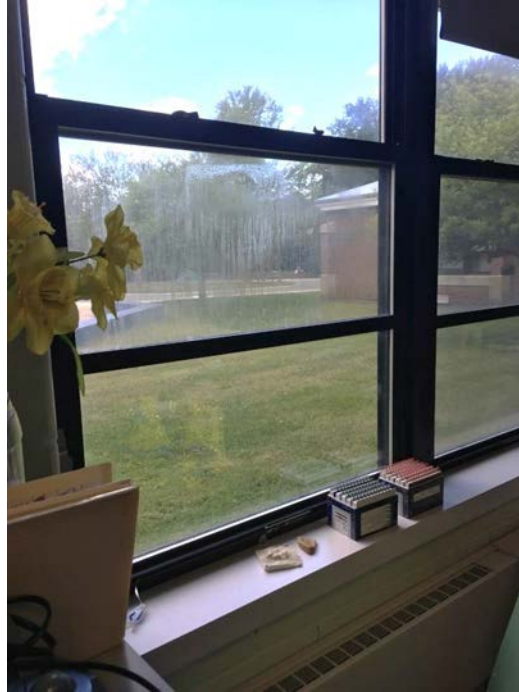
**Picture 17**

Shifts in the building have also damaged the window frames. Many windows are no longer plumb, resulting in gaps and failing components, such as gaskets. Windows not square to the casing can allow moisture into the building (Picture 17). These gaps have also allowed

**Condensation in window**

22. Examine windows gaskets, and replace as needed to prevent moisture in windows.
23. Periodically check window closure/tightness to prevent water entry and insects from building nests in the openings. Consider caulking material to seal windows during heating season.

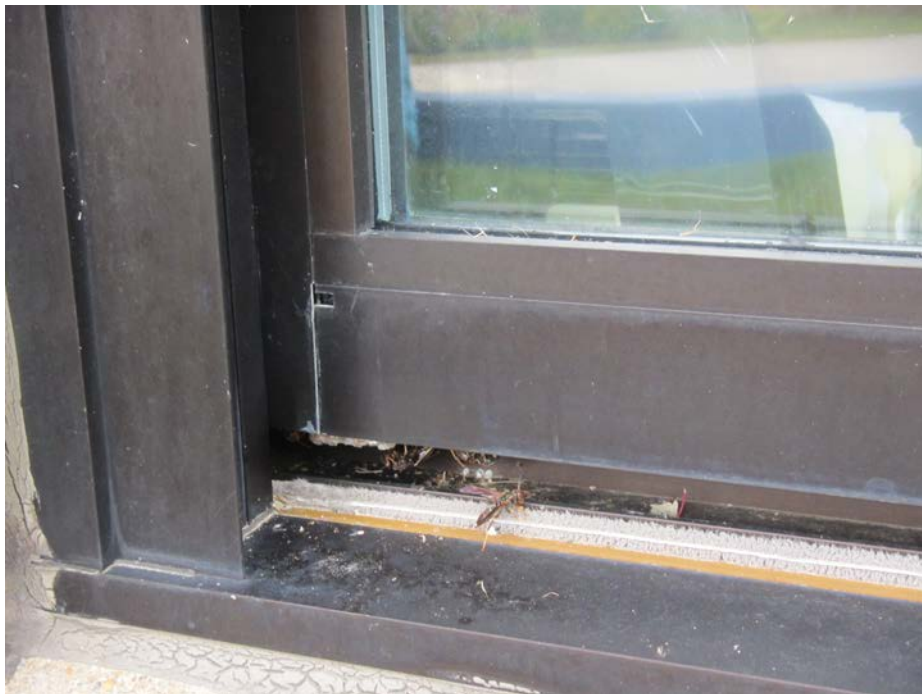
**Picture 18**

insects to nest in the building (Picture 18). Hornets' nests were observed on the exterior portion of a number of windows around the school. These nests should be removed to prevent injury. The building exterior should be examined periodically to ensure that insect or bird nests are identified and promptly removed.

**Hornets and nest in damaged window frame**

24. Ensure exhaust ventilation is operating in areas with photocopiers to remove excess heat and odors.
25. Contact a pest company to implement integrated pest management practices for removing and reducing hornet nesting around building.

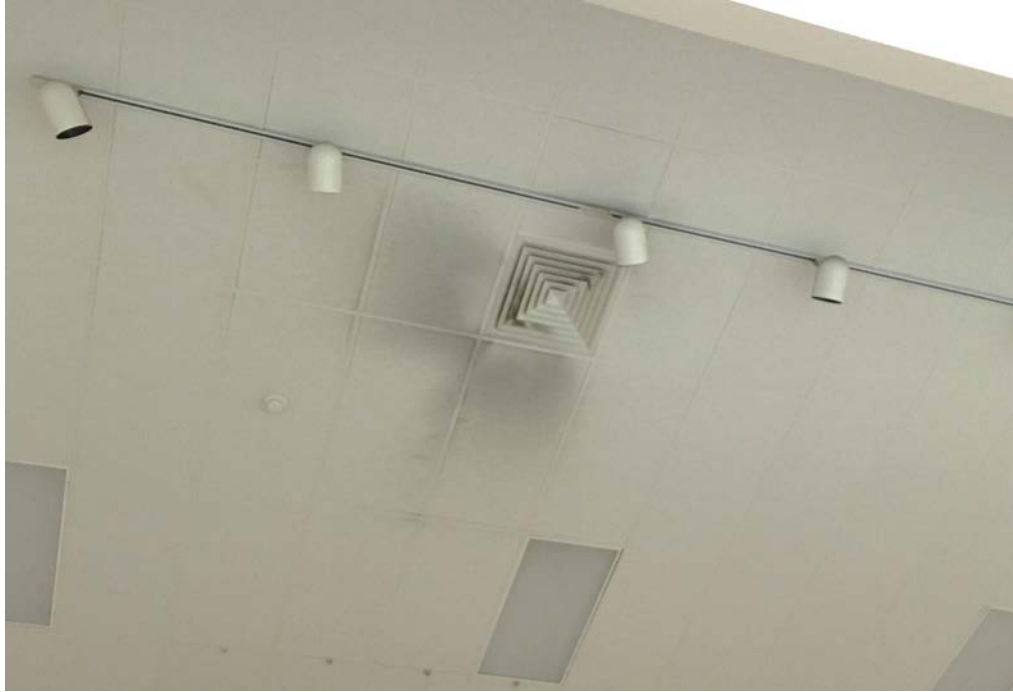
**Picture 19**

Dust was found settled or adhering to ceiling tiles around ceiling-mounted supply diffusers (Picture 19), classroom exhaust vents, personal fans, and flat surfaces. Dust can be reaerosolized and cause irritation. The aforementioned surfaces and items should be cleaned regularly with a high-efficiency particulate arresting (HEPA) vacuum or wet wiped.

**Dust accumulated on ceiling tiles around supply diffusers**

16. Ensure exhaust ventilation is operating in areas with photocopiers.
17. Regularly clean/vacuum univent cabinets, supply/return vents and fans to avoid aerosolizing accumulated particulate matter.
